Loading and mobility of faecal and chemical contaminants in shallow groundwater systems in Lukaya Town Council, Kalungu district, central Uganda

Water sources in Lukaya TC

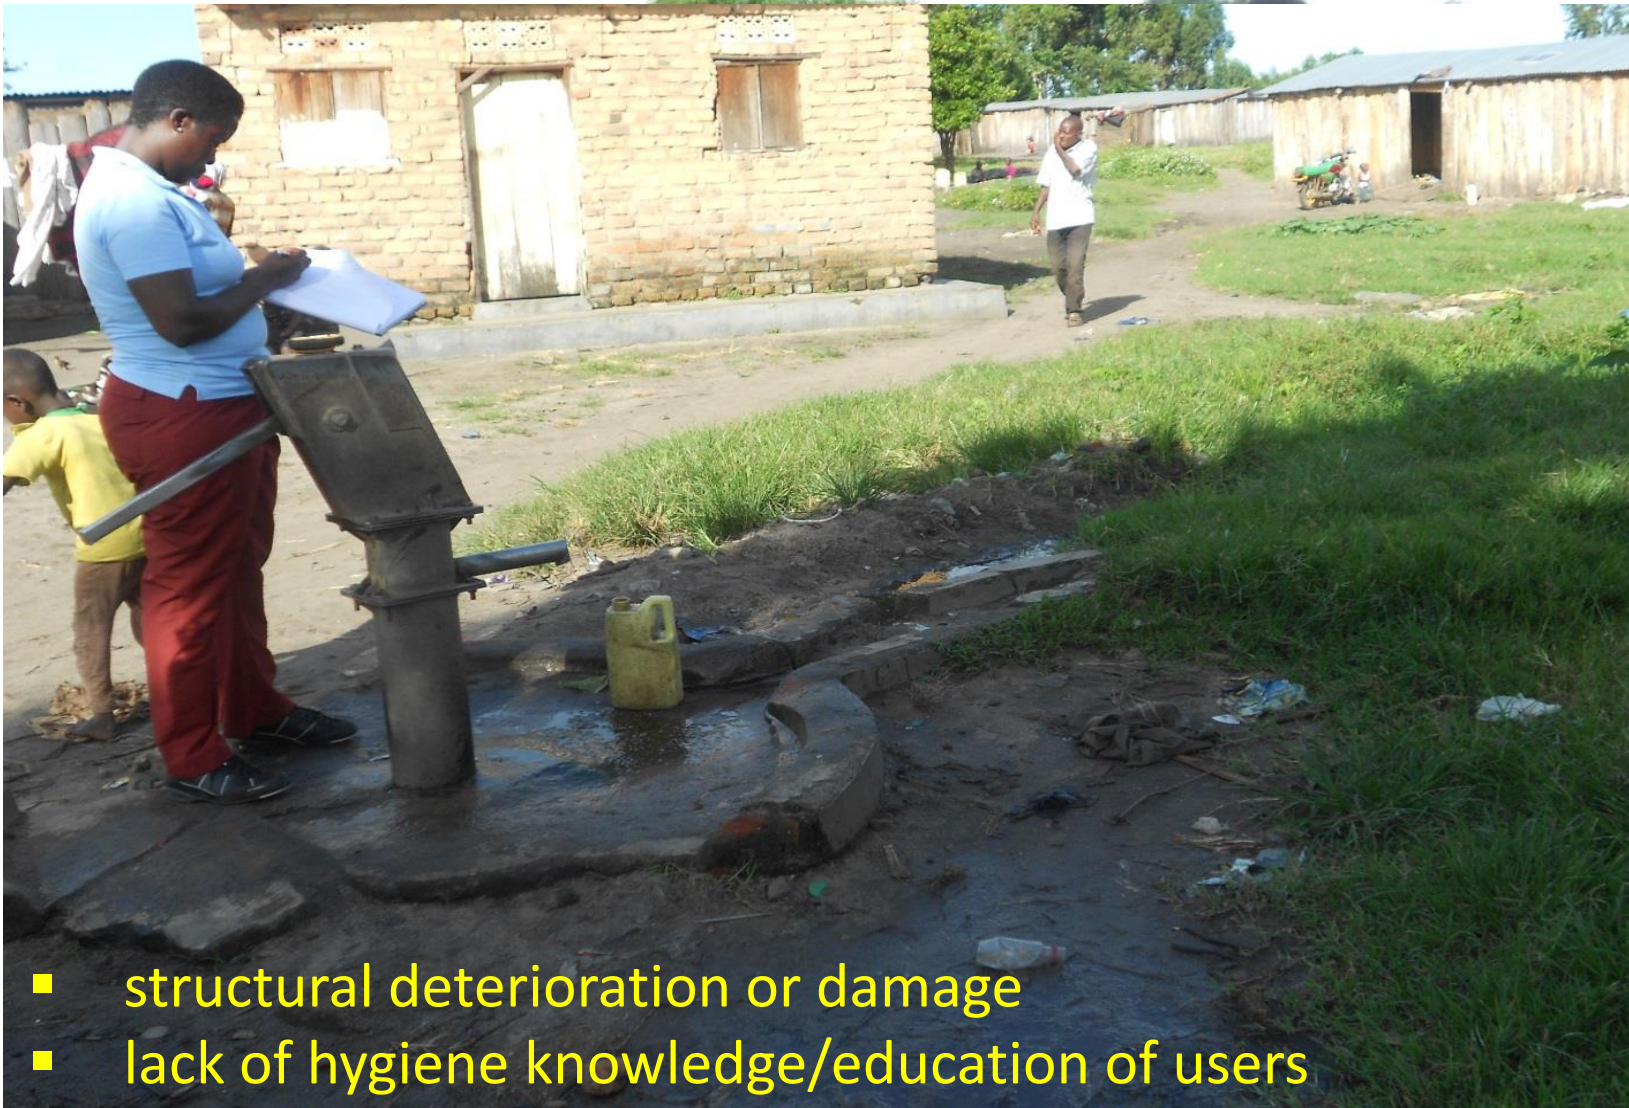
- Reasons for the presence of sanitary-risk factors at a source/facility

- structural deterioration or damage
- lack of hygiene knowledge/education of users
